Drainage Assets - Visual Inspection Report

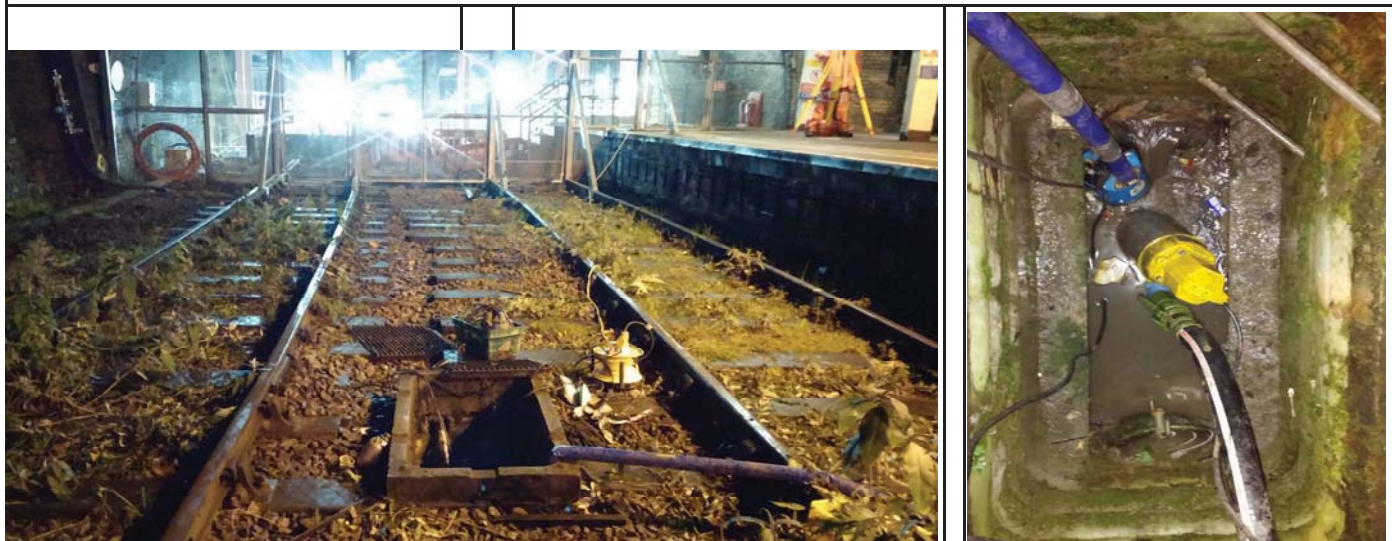
Out	Ref	Invert	Depth	Diameter	Material
	X		1200	300	Corrigated Iron (Bunged Off)
	Y				
	Z
